# SIKA AT WORK

## WASTEWATER TREATMENT PLANT, MOLA DI BARI, ITALY

# REFURBISHMENT OF SEDIMENTATION TANKS

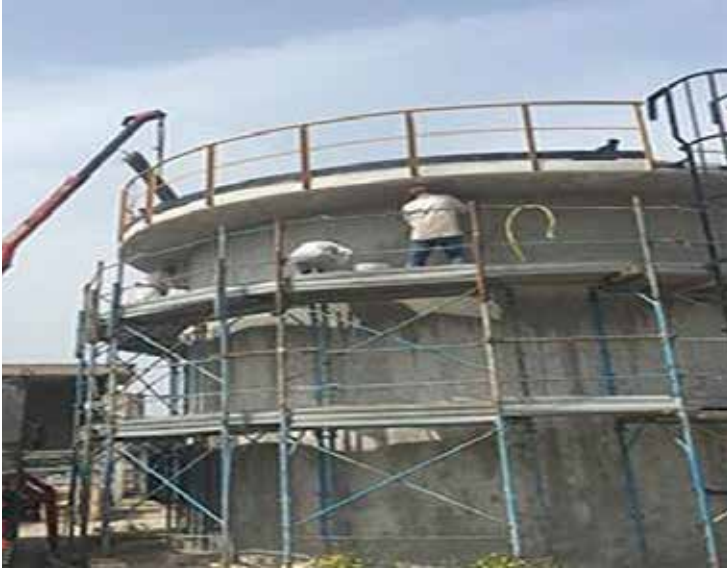
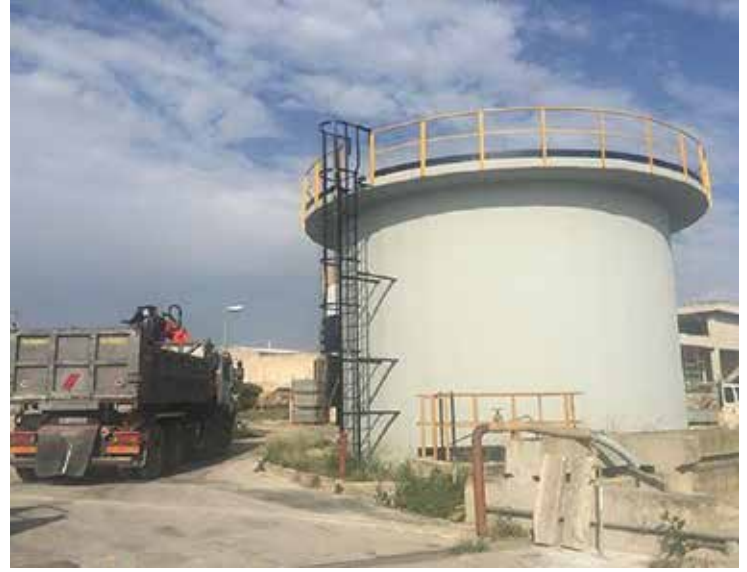
The condition of the sedimentation tanks required complete refurbishment of sedimentation tanks, including structural and cosmetic concrete repair and waterproofing with membranes chemically resistant against the corrosive substances that could be found in the tanks. Additionally, considering the proximity to the sea of the whole installation, external concrete repair and protection against potential chloride corrosion had to be considered.

- Sandblasting of reinforced concrete surfaces
- Local repairs with SikaEmaco® S 498 FR
- General levelling with SikaEmaco® N 405 FC
- Priming using Xolutec technology with Sikagard® P 770
- Chemical resistant waterproofing using Xolutec technology with Sikagard® M 790

- Priming with Sikagard® P 310
- Colored protective coating with Sikagard®-320
