# SIKA AT WORK

## WATERPROOFING OF DECK, FOSSANO VIADUCT, ITALY

CONCRETE PROTECTION: Sikalastic®-6100 FX

# WATERPROOFING OF VIADUCT DECK

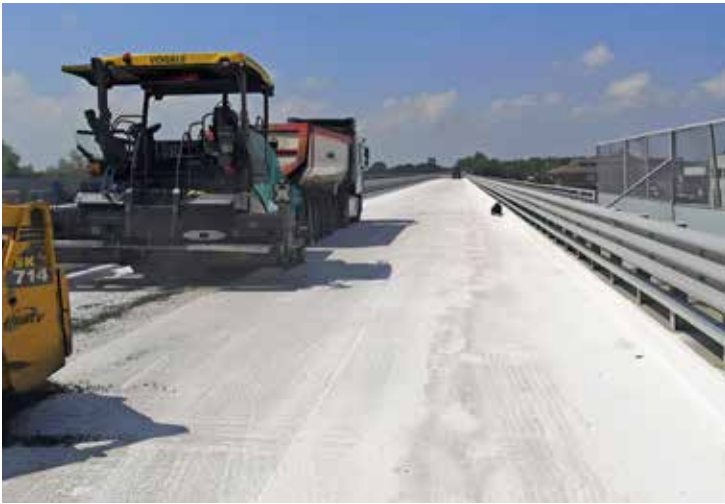
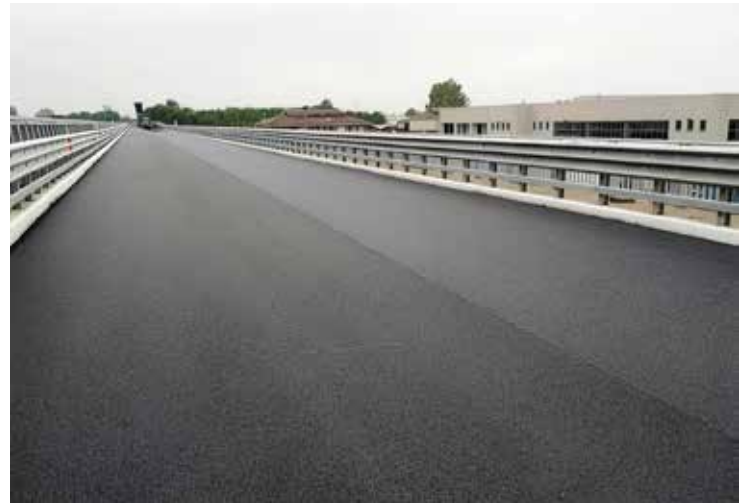
The reconstruction of the viaduct included the casting of a new concrete slab and the installation of barriers. Additionally, it was necessary to apply a waterproofing membrane to the concrete slab, before the application of the asphalt pavement to protect the concrete against water damage.

- Structural refurbishment with SikaEmaco® S 444 FR, R4 class, concrete repair mortar reinforced with metal fibres.
- Reprofiling and levelling of the surface with SikaEmaco® S 950, R3 class, polymer modified concrete repair mortar reinforced with polyacrylonitrile (PAN) fibres.
- Sealing of movement joints with Sika MultiSeal®-924 thermoplastic tape.
- Waterproofing of bridge deck with Sikalastic®-6100 FX single-component elastic membrane before application of hot-rolled asphalt.

Total area waterproofed: approx. 30,000 m<sup>2</sup>. Sikalastic®-6100 FX applied with a thickness of 2.5 mm and approx. 2.35 kg of product per m<sup>2</sup>. The junction for Marene, which is close to the viaduct, was reopened to traffic in August 2019. The rest of the Fossano ring road was reopened in August 2020, three years after the collapse of the viaduct. The use of Sikalastic®-6100 FX instead of traditional cementitious two-component waterproofing membranes saved approx. 30 tonnes of waterproofing material.
