WASTEWATER MANHOLE CHAMBER, NORWICH, UK

CONCRETE PROTECTION: Sikagard®-7000 CR

CONCRETE REPAIR: SikaEmaco® N 5200

WATERPROOFING AND CONCRETE PROTECTION OF CHAMBER WALLS

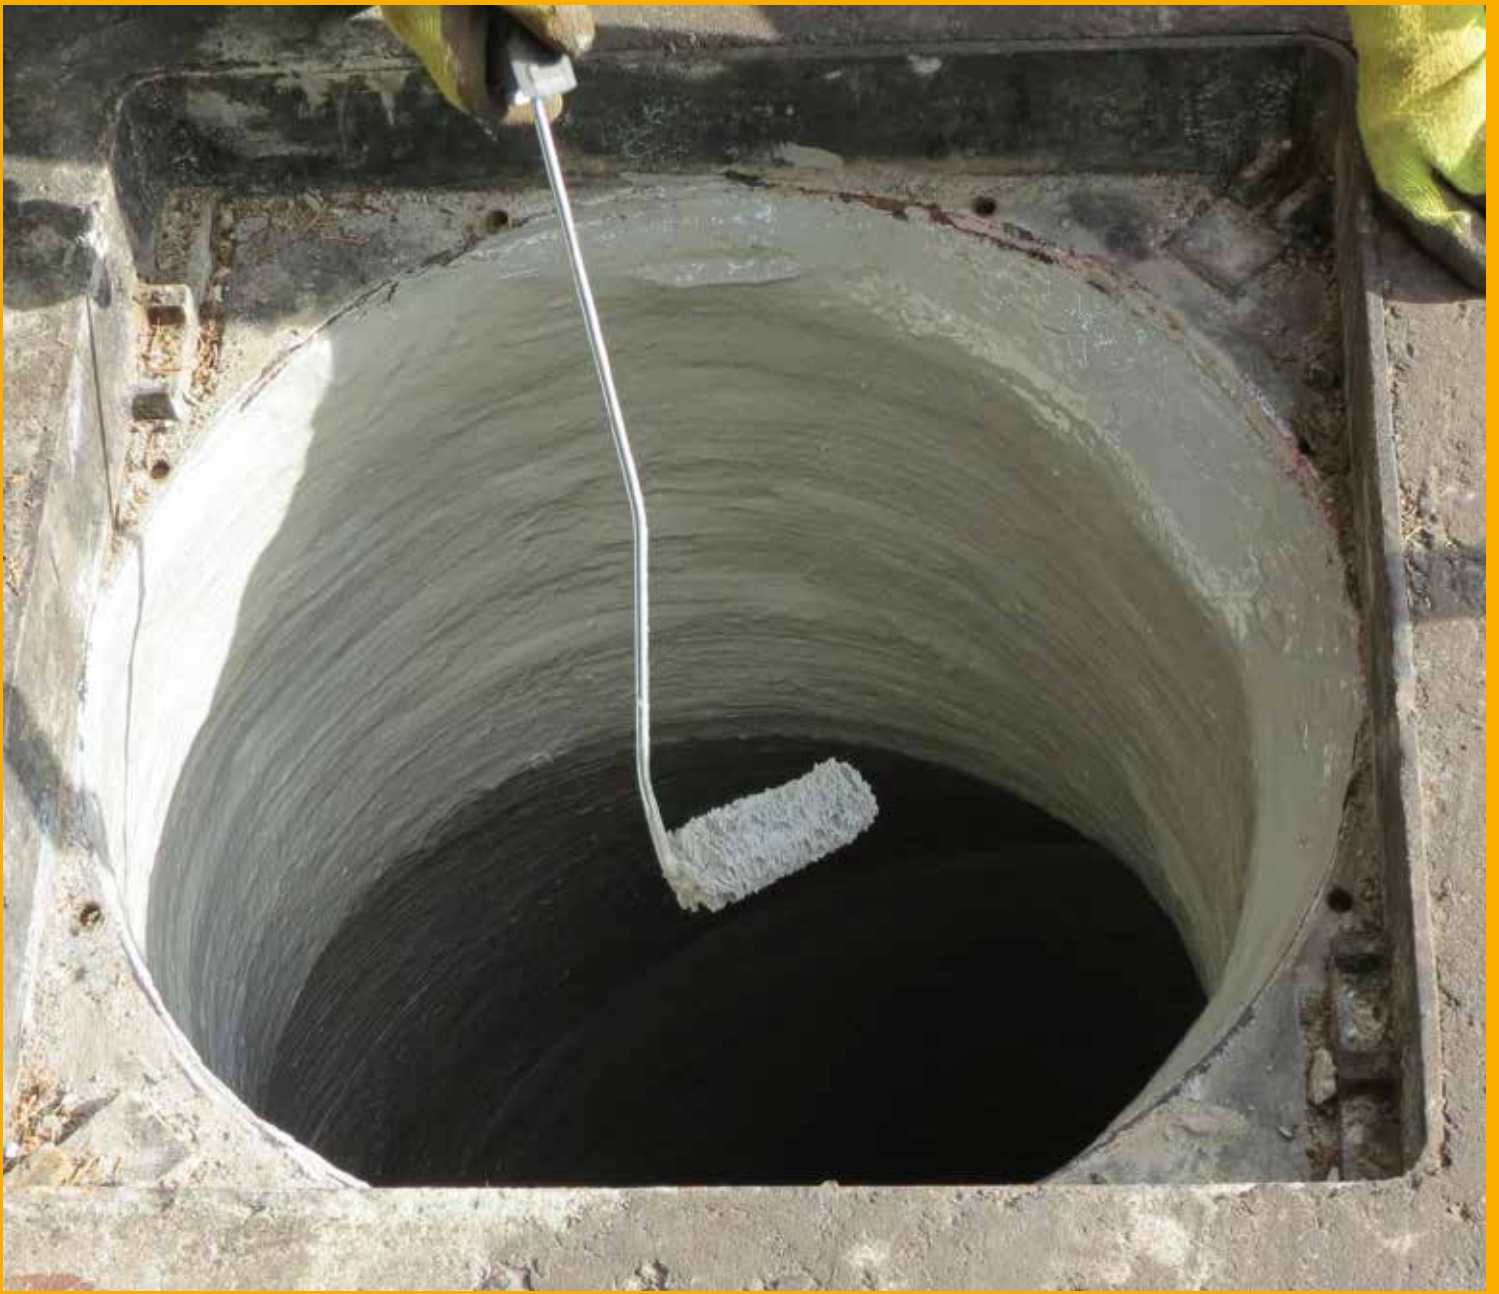
The wastewater manhole chamber had shown signs of biogenic sulphuric acid corrosion which had eroded the concrete lining. The structure required the concrete to be relevelled and protected with a coating resistant to this form of attack from anaerobic bacteria.

The concrete surface was treated with high pressure water to remove all contaminants. SikaEmaco® N 5200 cementitious rapid setting levelling mortar was applied at 5 mm thick to reprofile the concrete surface. After 3 days Sikagard®-7000 CR system was applied: Sikagard® P 770

primer, followed on consecutive days by 3 coats of Sikagard® M 790 top coat, initially Red, followed by two coats of Grey. Before each primer or top coat was applied a hot air blower was lowered into the chamber to remove any condensation on the concrete surface.
