# SIKA AT WORK REHABILITATION OF THE LOCSIN MONTELIBANO HOSPITAL, PHILIPPINES

STRENGTHENING: Sika® Carbodur®

# REHABILITATION OF THE LOCSIN MONTELIBANO MEMORIAL REGIONAL HOSPITAL, PHILIPPINES

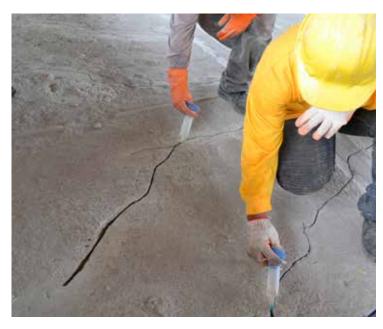
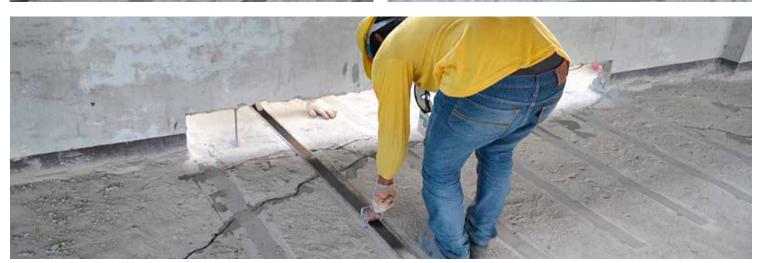
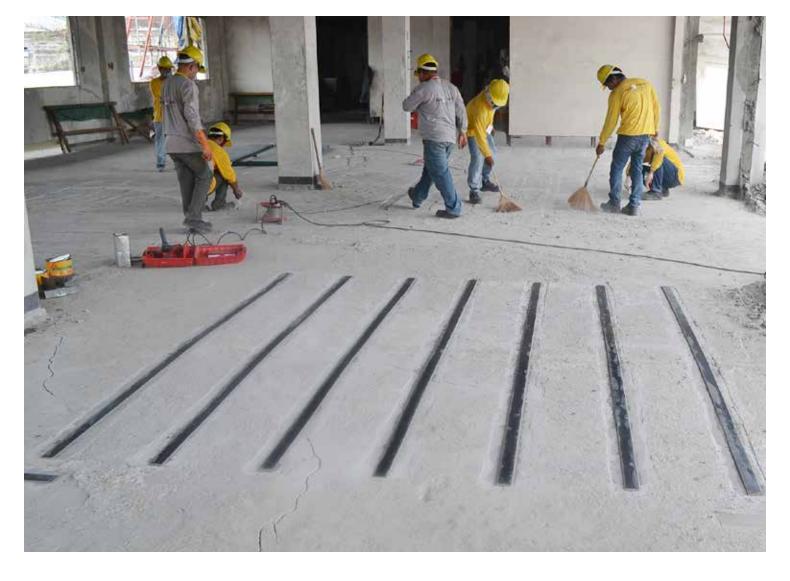
Approximately 70 mm of the surface plaster and topping were stripped off from the suspended slab. The crack concrete slab was repaired through crack injections with the use of Sikadur® 752. Due to the width of the cracks, they were easily filled by gravity feed.

Epoxy adhesive was applied to the prepared surface edge in order to level the surface overlay using Sikadur® 31 CF. Sika® CarboDur® S512 was installed to the concrete slabs to strengthen and compensate additional cracking and stresses of the structure

Finally, concrete mortar and topping was applied to overlay and protect the Sika® CarboDur® plates as well for aesthetic purposes.
