VIVAQUA-TAILFER BUILDING FACADE, BELGIUM

CONCRETE PROTECTION: Sikalastic®-6100 FX

REPAIR AND PROTECTION OF BUILDING FACADE

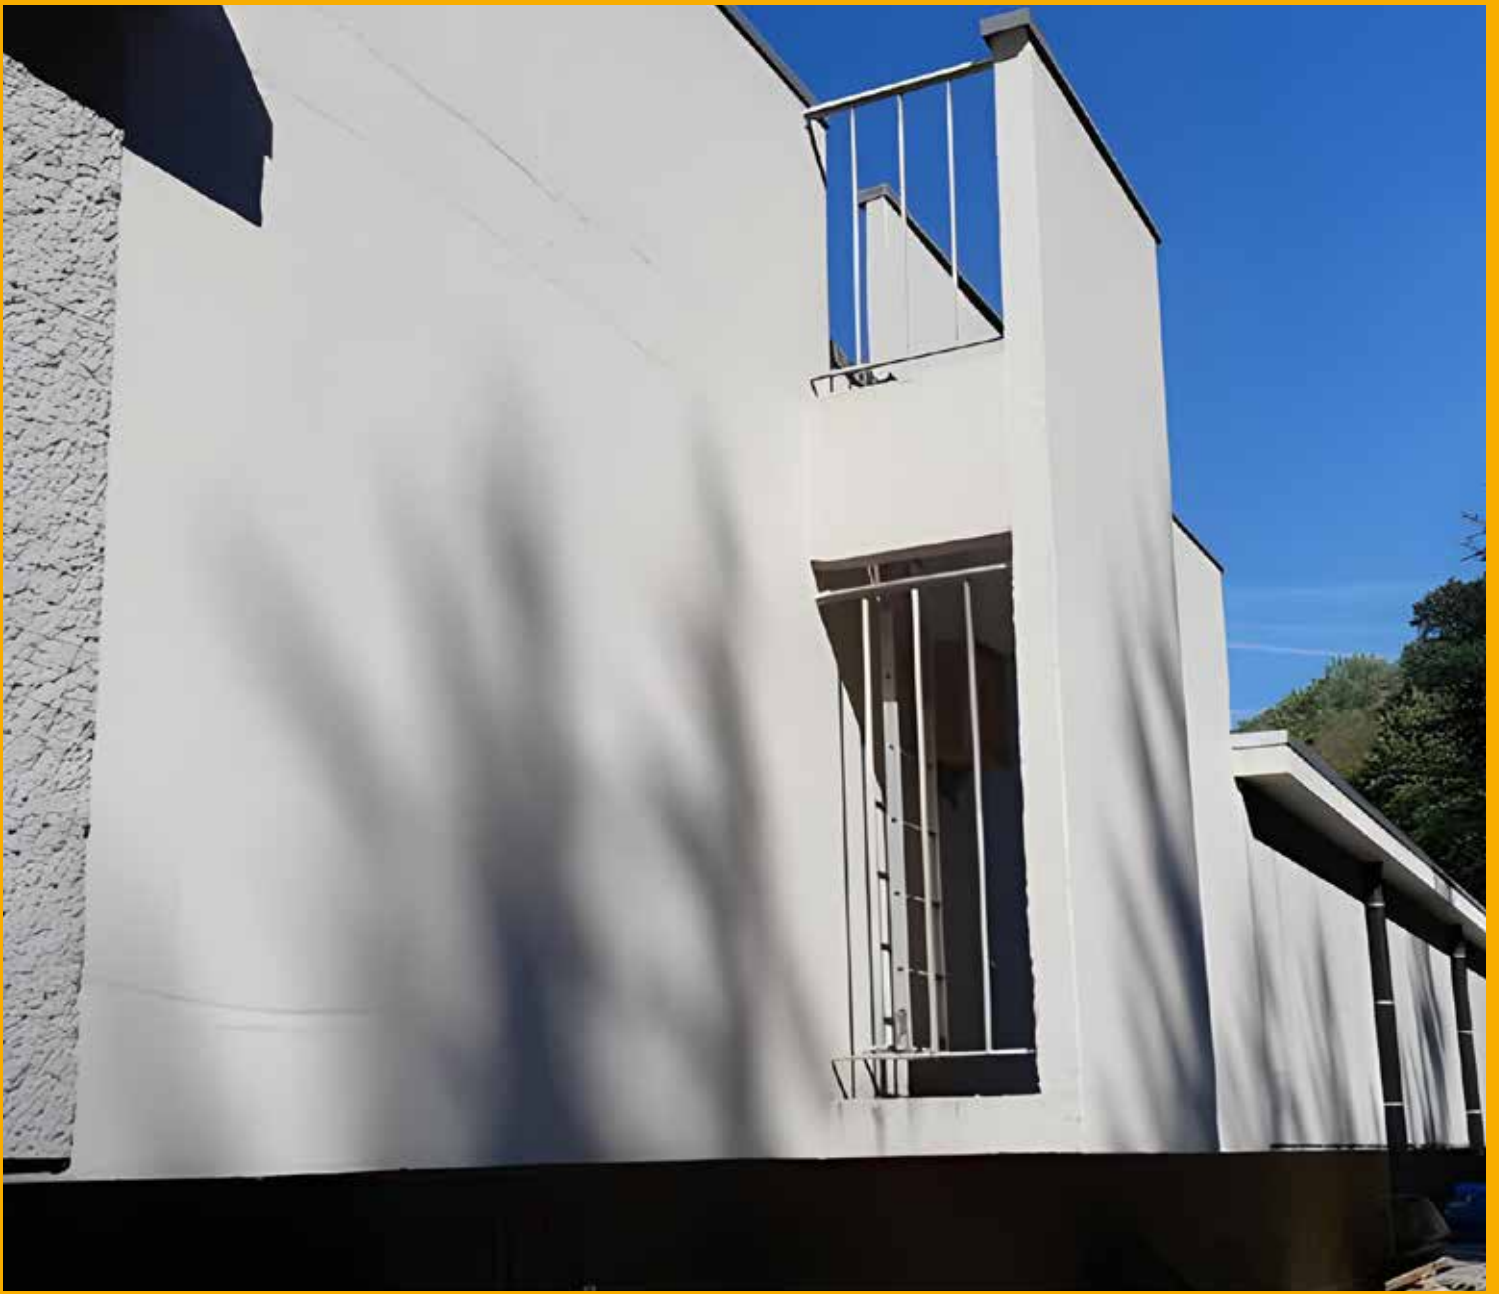
The prefabricated elements on the facade of the Vivaqua-Tailfer sludge treatment plant building were affected by carbonation. There were visible concrete spallings, cracks and reinforcement showing signs of corrosion. It was necessary to repair and protect the elements while keeping the initial roughcast appearance.

Sikalastic®-6100 FX, a lightweight, elastic membrane for waterproofing and protection against carbonation of concrete, was chosen because it has an outstanding rebar protection capacity.

Its texture, thickness, crack-bridging capacity and color (light grey) have kept the original appearance of the facade.

- The building is renovated, retaining the initial roughcast appearance.
- The prefabricated elements are waterproof and protected against efflorescence.
- Thanks to the crack-bridging capacity of the membrane, the elements are protected against cracks.
